Pen yr Ergyd Spit Evaluation – October 2018

A response to a request for information as to how the LIDAR data provided by Ceredigion County Council is utilised to further the understanding of the processes at work in the Teifi estuary.

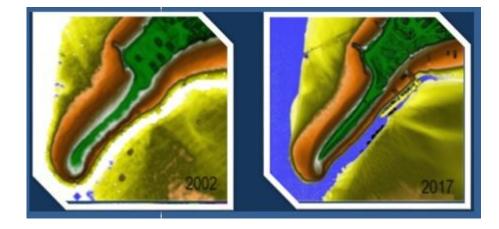
Fig 3. 2002 – 2017 Pen yr Ergyd Lidar extracts.

Source: Pen yr Ergyd Monitoring Data 2002 – 2017. TDW 2017 **Sediment Transfer Trends** – [see Fig. 4] The lidar data suggests that the spit lost more sediment than it gained between 2002 and 2007. 2008 revealed a modest gain, but by 2009 sediment was again being lost. The 2011 data shows a marked increase, which in the most part, reflects the work of the management programme. 2012 shows a larger sediment loss followed by an almost equal gain by 2013, which continues into 2014. From the high point of 2014 there has been a continual loss of sediment despite annual interventions to manage the spit profile. [See Fig.4]

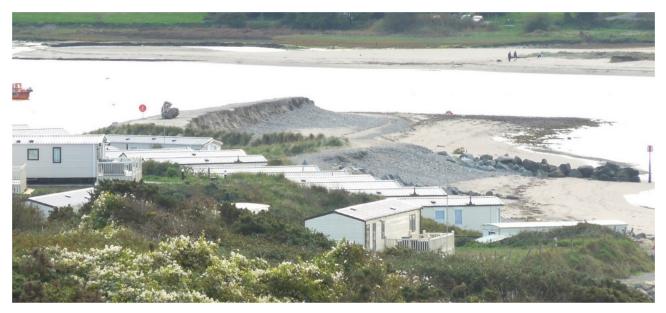
Fig 8. 16/10/2018 Pen yr Ergyd Spit. Note the engineered upper surface ~5.2m OD. The near vertical erosional scarp along the reconstructed upper crest. Although this is post storm Callum there is no evidence of over-run or debris flows on the inner slope. The large feature on the spit crest is a tree root place there by the ATFL. Source: Chris Evans.

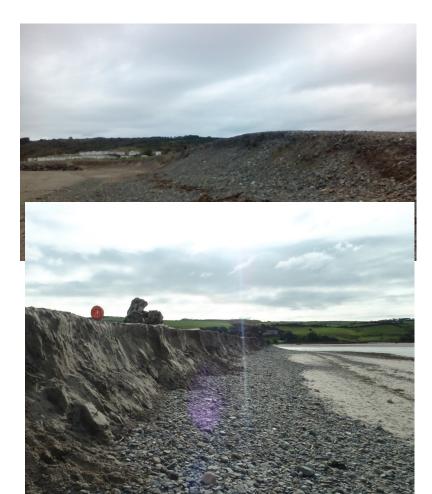
Fig 9. 02/10/2018 Pen yr Ergyd Spit. Erosional scarp in the reconstructed upper spit two weeks before. 7.5m wide crest reduced to 4m at the distal end.

Fig 10. 15/10/2018 Pen yr Ergyd Spit. Erosional scarp in the reconstructed upper spit. Crest 2m wide at distal end. Note absence of sand at the base of the freshly eroded scarp.

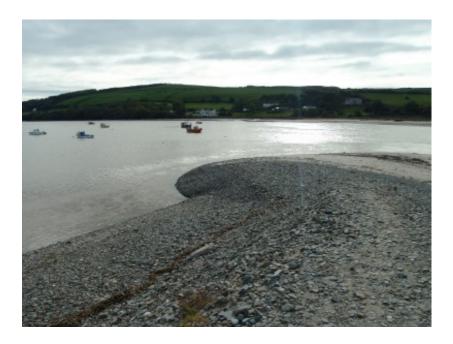
Fig 11. 15/10/2018 Pen yr Ergyd Spit Recurve. Newly expanded post storm Callum.

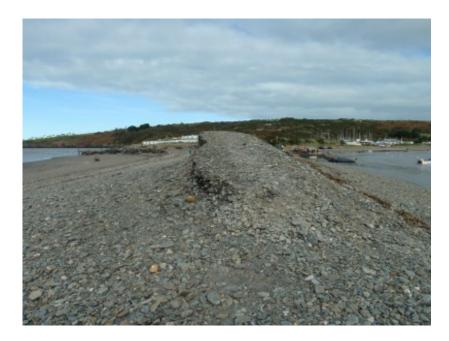
Fig 12. 15/10/2018 Pen yr Ergyd Spit – Distal End. The track down onto the recurve/foreshore has lost over 40% of its width in two weeks through erosion to its seaward face. Again, note the absence of sand.
